STRUCTURE CONDITION REPORT

BARGE CANAL FAIRPORT-LOCKPORT

MATERIALS BUREAU

STRUCTURE CONDITION REPORT
BARGE CANAL - WESTERN SECTION
FAIRPORT TO LOCKPORT

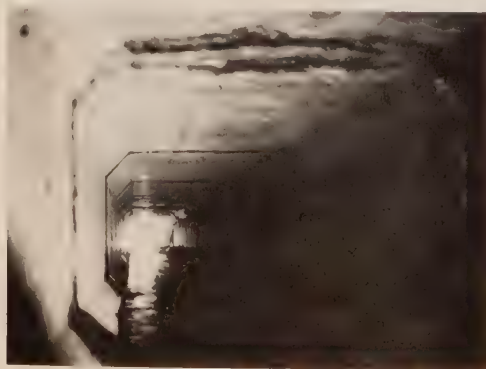
West Barrel - Looking North Toward Exit

East Barrel - Most of the joint areas were scaled 3-4" deep and 1' wide on each side of the joint. One joint near middle of barrel was leaking a constant drip size stream. The 2nd and 3rd joints in from the north or exit end were the worst. Scaling was 1-2' wide and 6" deep on each side of the joint. The ceiling had 3 areas that contained many efflorescent covered cracks and soda straws, but the areas were mostly dry.

West Barrel - Conditions in this barrel were similar to east barrel (joint deterioration and cracks). Steady drip size streams flowed through 4 of 5 joint areas.

The majority of the concrete was in good condition, but joint and other repairs are needed.

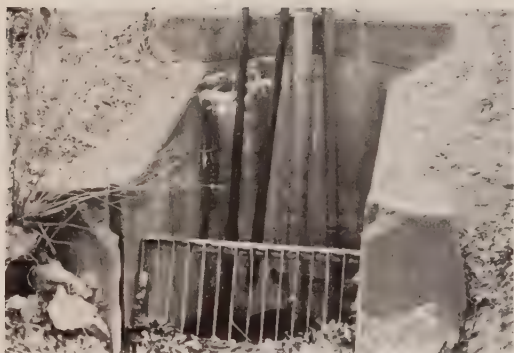
Entrance

Headwall contained a few cracks, but headwall and wingwalls were generally in good condition.

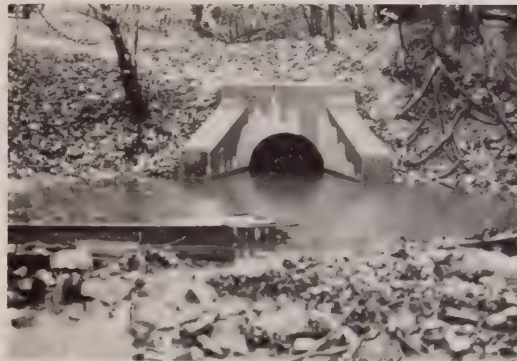
Extension Exit

Headwall had cracked vertically over top of arch, but the concrete was in good condition. This headwall is some 235' from where the culvert under the canal emerges into a manhole. This extension was in good condition.

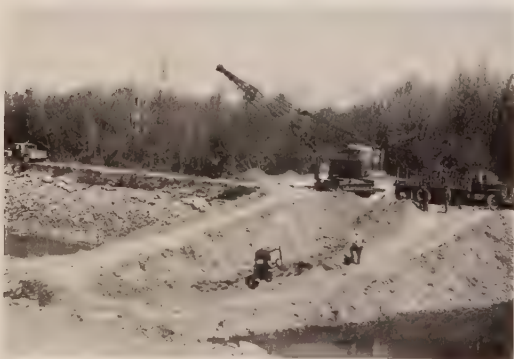
Canal Area Over Culvert 43

In the Spring of 1976, water was seen spouting up into nearly drained canal. Manhole exit had plugged with debris and water rose 5' over exit or 3' above level of canal water. Pressure caused drain cover at bottom of canal over culvert to blow out. During week of April 26-30, area was sandbagged off, but high water in canal from rains inundated area. Earth cofferdam was then built and mud removed until drain was found.

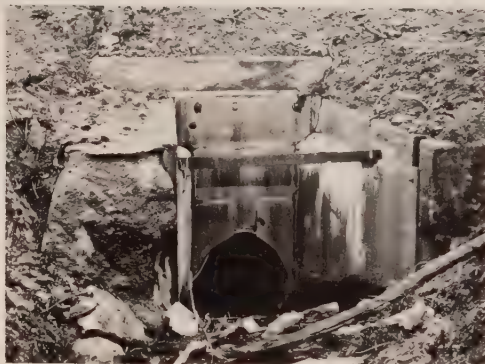
Entrance

Concrete arch behind headwall failed. Area excavated and 3-12' lengths of 36" corrugated metal pipe installed in Spring of 1975. Deteriorated headwall and wingwalls were faced with steel plates.

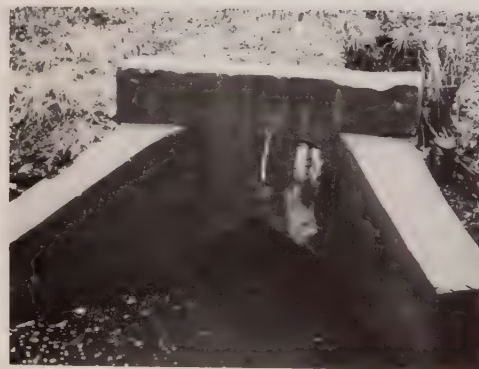
Exit

Headwall and wingwalls seemed to be patched with mortar. 1' deep erosion at wingwall waterline

From south to north (entrance to exit) - Last section in of corrugated pipe has been cut all along the top, possibly to squeeze pipe to smaller diameter, but there was a 3-4" gap between the pipe and the circular arch wall. Next 10' is concrete arch, 70% of which has scaled areas up to 1' deep. Cast iron pipe then begins. Two 5" diameter holes one on each side of joint between 2nd and 3rd pipe sections, patched with 10" square steel plate. One patch has fallen off (steel plate is on outside also). Between 3rd and 4th sections, roots and 3 constant drip size leaks. Last 15' concrete arch. 1 scaled area 6" deep above the water line and 1 scaled area 3" deep at the water line. Repairs are needed.

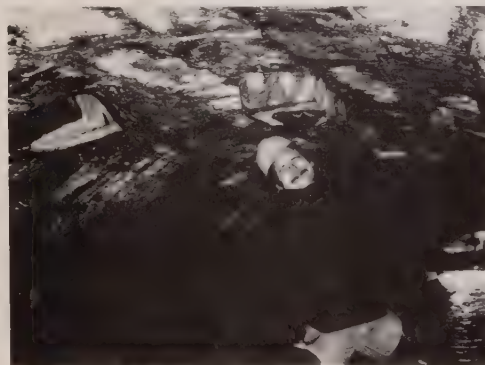
Barge Canal Construction

Mileage

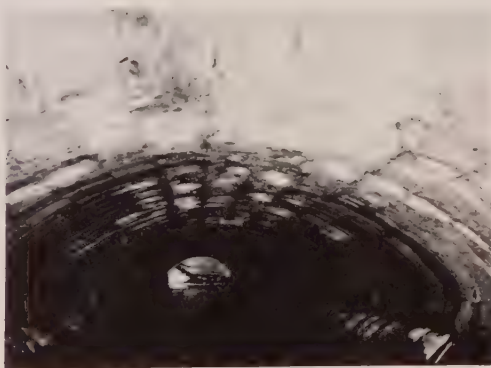
GREAT LAKES - HUDSON RIVER WATERWAY IMPROVEMENT

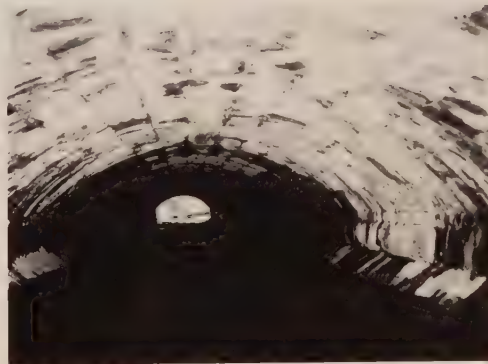
THE BARGE CANAL SYSTEM

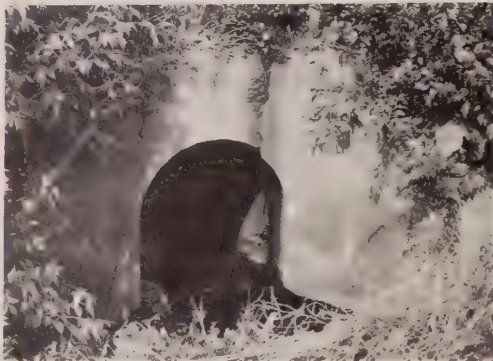
Canal structures in addition to those already listed include such facilities as bypasses, spillways, syphons, culverts, approach walls, dykes, flumes, canal retaining walls, etc.

BARGE CANAL DIMENSIONS

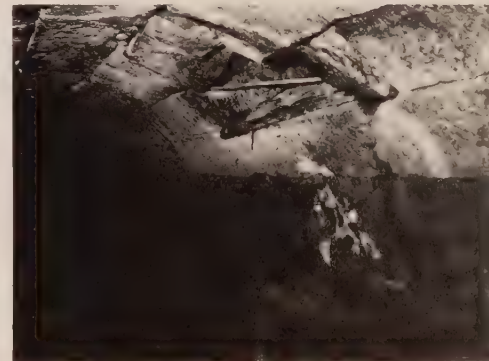
East Wall - partially missing block in ceiling, stick and board wedged in 1' deep hole.

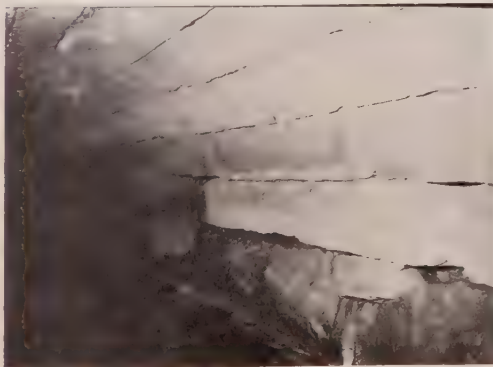
East Wall - Looking North, note open joints

From north to south (exit to entrance) - between 10 and 20' into the concrete arch, there was a longitudinal overhead crack with some seepage. Stone block arch begins after 50'. About 100' in, a 1' x 2' stone block near base of stone block arch wall was missing (heavy water flow could be heard in rocks behind missing block). About 3' south of 2 plugged drains, a steady flow of water was coming through joints on east wall at the spring line. No mortar between the stone blocks. 75' from south end, 1 stone block on east and west wall are partially missing, but there was no leakage. Last 40' of concrete arch at south end was in good condition. 25' in from south end was a 12" diameter syphon in the ceiling. Repairs are needed.

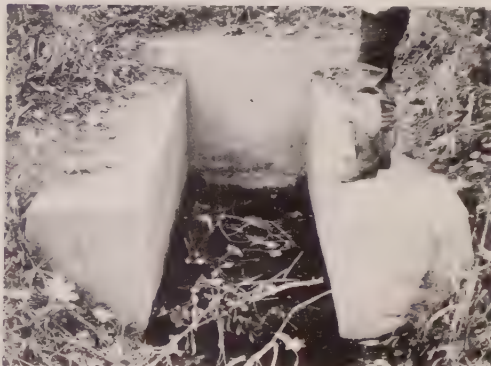
Exit

Headwall and wingwalls in good condition.
Culvert well filled with debris.

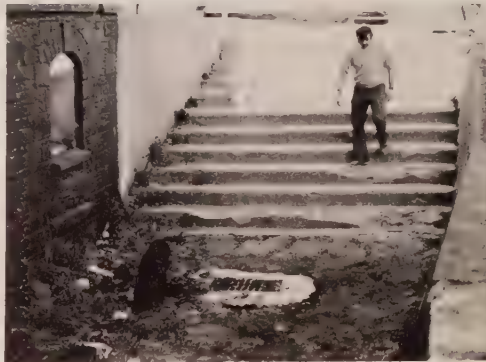
Entrance

The grate is apparently the entrance to this culvert which drains low areas behind the south canal wall.

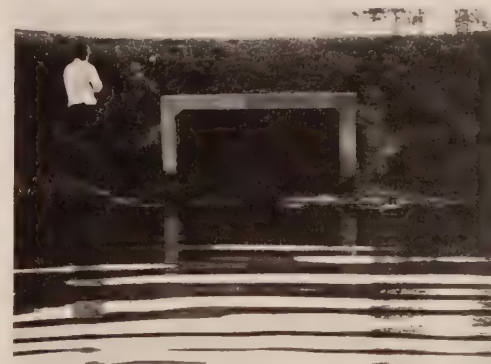
New Common Exit for Culverts #59 and 59½

Good condition, some joint seepage.

Most joints had seepage and some were covered with soda straws. Half the concrete pipe sections had cracked 1' south of the joints as denoted by efflorescence and soda straws. Some cracks went all the way around the semi-circular arch and the others 1/3 to 1/2 the way around. 36" connection in good condition. Installed by Village of Brockport Permit #66-1-9

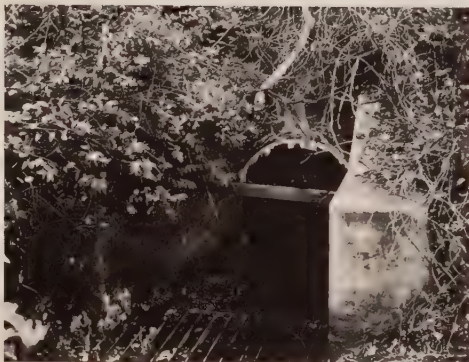
Entrance

Headwall was in fair condition. Cracked, but intact. Wingwalls were in good condition. Trash rack had fallen over.

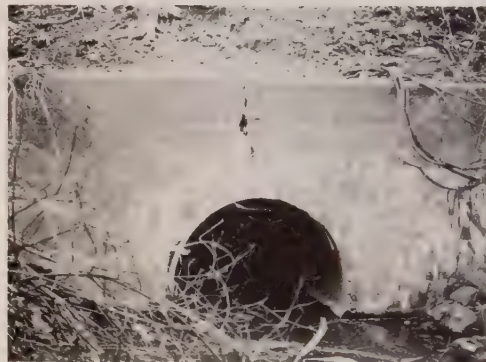
Exit

Headwall had one vertical crack in the center. Numerous transverse cracks with efflorescence. Structure in fair condition.

From north to south (exit to entrance) - The 2nd joint in the cast iron pipe has a 5" gap. (Pipe was not pushed into 5" long bell housing.) Concrete can be seen surrounding pipe. Joint has some seepage. 75' into pipe and 1' south of joint, a 6" square hole at the top of the pipe had a steel plate patch over it. This area leaked 6 steady drip streams of water. Some seepage through joints, but most were dry. Possible minor repairs needed at patch.

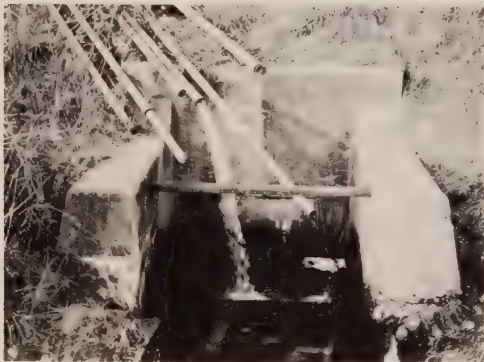
Entrance

Some cracks on headwall and wingwalls, but generally in fair to good condition. 6 syphons, 1 active.

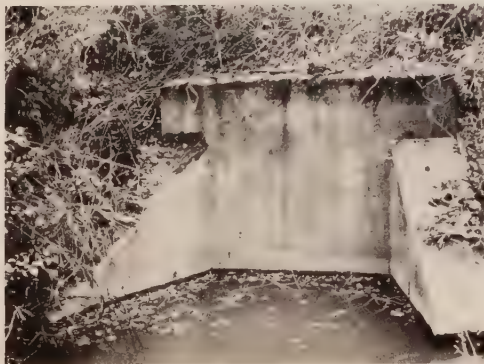
Exit

A few small cracks, but headwall and wingwalls generally in good condition.

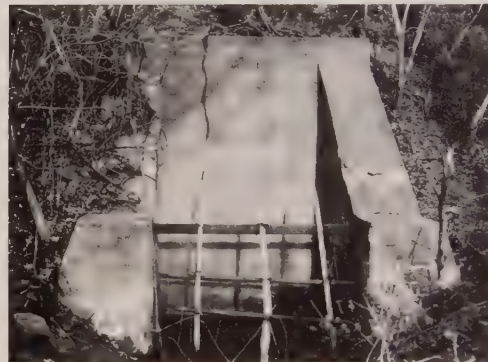
Entrance

Headwall in good condition. Cracks and scaling on wingwalls, fair condition. Note attempts to fence off culvert well.

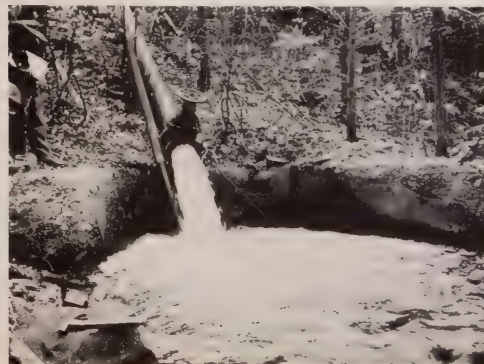
Exit

Headwall and wingwalls in fair condition, 1-2" deep scaling. 2 syphons, 10" syphon active.

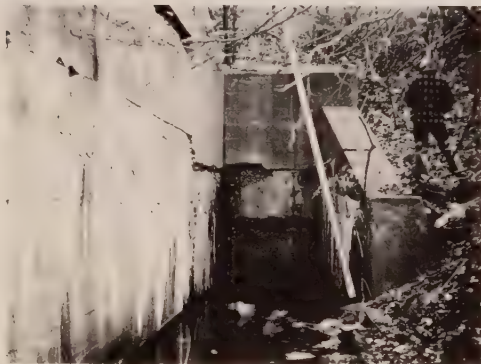
Exit

Top 6' of headwall in good condition.
Bottom 10' of headwall in fair to poor condition.
1 syphon. Roots growing out 8" deep scaled area 10'
from top of headwall. Right wingwall was delaminated
and in fair condition. Left wingwall is actually a
large retaining wall (40' long, 20' high) for an aban-
doned road over the canal. Old road had twin 4' x 4'
stone block arch culverts. North culvert has collapsed.
South culvert has a 42" corrugated metal pipe inside.
Gap between stone blocks and metal pipe grouted.

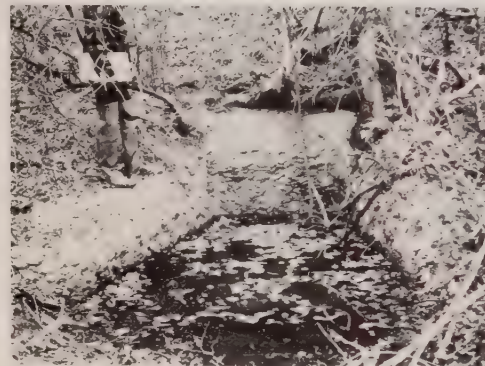
Exit

Headwall and wingwalls in poor condition. 4" deep
scaling on headwall and much deeper on wingwalls.

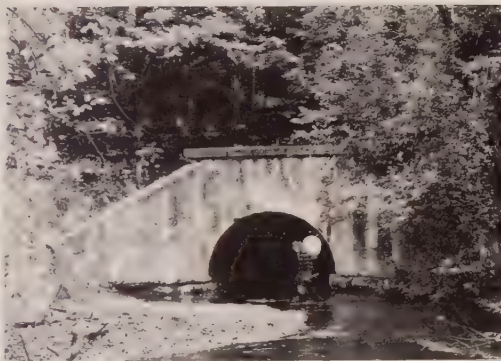
Entrance

Headwall and wingwall areas in fair to good condition with cracks, cold joints and scaling. Left wingwall was partially undermined. South end concrete arch constructed when embankment was widened for railway. See Holley Trough Introduction and Plans.

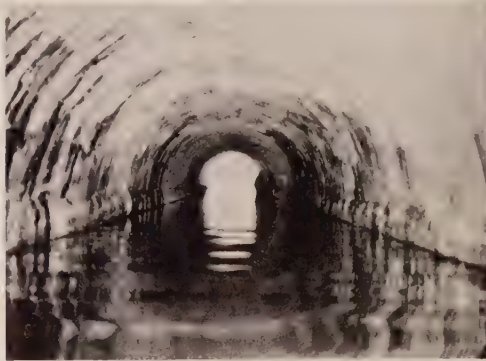
Looking South Toward Entrance

Heavy buildup (2" or more) of mineral deposits on the stone block arch walls from slow seepage. A concrete encased sewer pipe runs along the west side of the barrel. One can walk along the top for about 100' from the south end before the water gets too deep for hip boots.

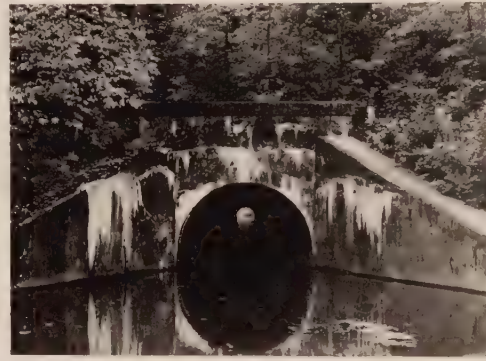
Exit

Headwall and wingwalls in fair condition due to numerous cracks. Water in culvert about 4' deep.

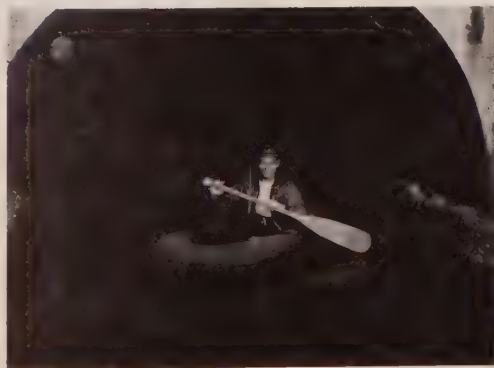
From south to north (entrance to exit) - south entrance for 50' was concrete arch. The arch was in good condition except for scaling along the bottom portion. The stone block arch had a large number of short soda straws and heavy efflorescence with constant dripping for the first 15'. The arch was dry for the next 40-50', after which dripping continued the length of the barrel to the north concrete arch (a few steady drips, but nearly all were slow, 1 drip every few seconds). Efflorescence from 1-3" thick, in streaks, covered both walls and indicated active seepage. North concrete arch had approximately 6 areas of spalled concrete 2" in depth. Expanded metal lath, used in the construction of the north arch, was approximately 5% exposed due to spalling of concrete. North concrete arch was dry, except for slow seepage at a few joints. Except for a few voids between some stone blocks, the blocks in the barrel were in good condition. None seemed to be missing, slipped or cracked, but it was difficult to see under the thick coating of mineral deposits. Although the culvert appeared to be fair to good condition, no inspection could be made below the water line.

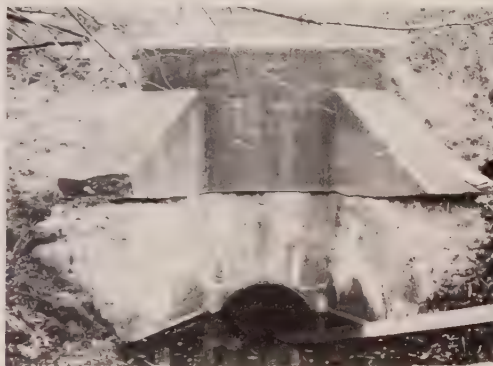
Exit

Top half of headwall and top of wingwalls in good condition. Bottom section of headwall area and wingwalls in fair to poor condition with deep scaling, cracks and delaminations. Water in culvert could be lowered 1-2' by cleaning out ditch.

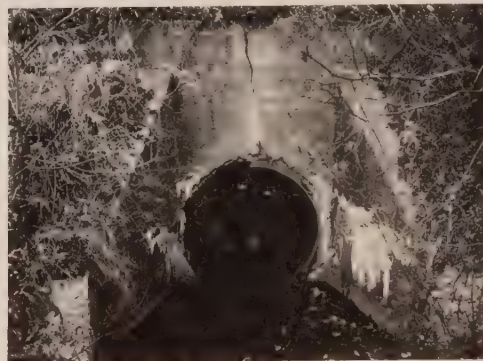
Entrance

Headwall had a vertical crack over the center of the pipe. Generally headwall was in good condition. Wingwalls were in fair to good condition with some transverse cracks and efflorescence in the middle.

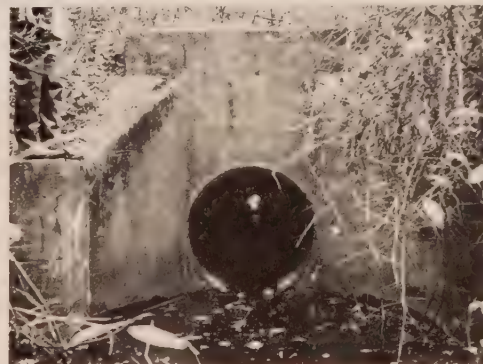
Exit

There was one vertical crack in the headwall. Otherwise, headwall and wingwalls were in good condition.

Cast iron pipe in good condition. Some drippage at 24" center drain. Slight zig zag in pipe noticed from the ends, but it cannot be detected inside.

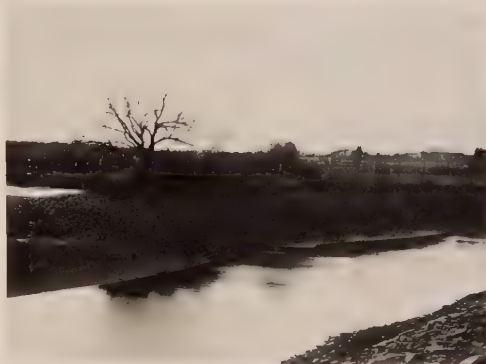
Exposed sheetpiling on south embankment. Widewater area is at left. The south end of this culvert was plugged prior to creating the widewater area. See Introduction, Canal Culverts.

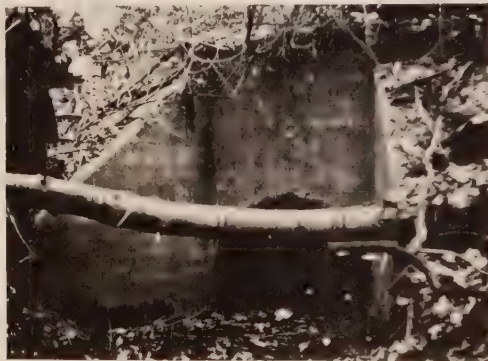
Exit

Headwall and wingwalls in good condition

No active leakage, but 2 joints in north half had 1' long stalagmites. No leakage at 18" drain at center. South half of pipe partially filled with silt, gravel.

South end of pipe ended at round wooden plug. Entrance area filled with concrete prior to flooding widewaters. Cast iron pipe in good condition.

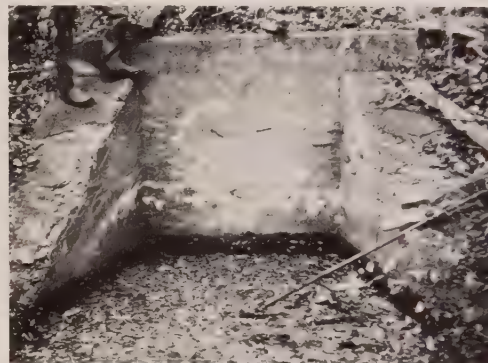
Entrance

Headwall and wingwalls in fair condition due to many cracks. Sealing at end of wingwalls. Water level dropped 6" by cleaning out channel at exit end.

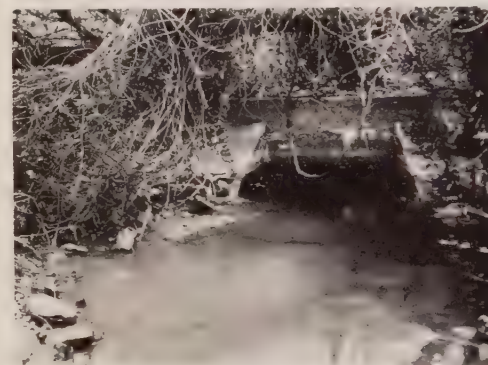
Exit

Headwall and wingwalls in fair condition due to many cracks. Right corner of headwall missing.

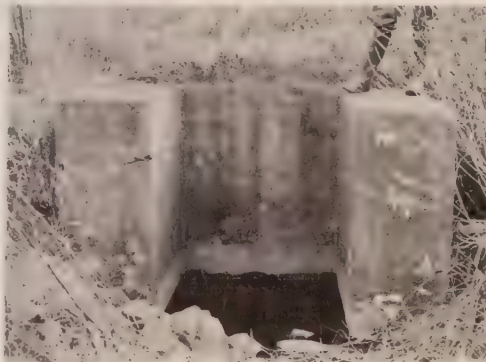
The center pier also contained little delaminated concrete, except for the pier noses. Both noses contained a much higher percentage of delaminated concrete than the sides, but all faces still appeared in good condition.

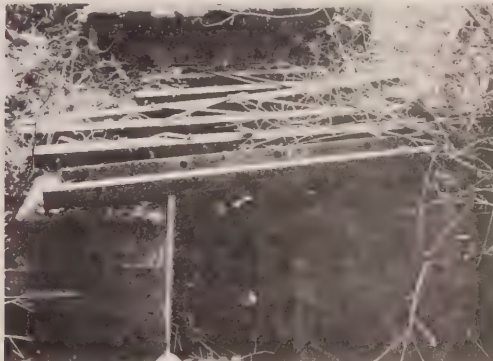
The Albion Guard Gate is located 1.4 miles west of downtown Albion. On April 7, 1976, this structure was visually inspected, sounded for delaminations and 2 cores were taken from the south abutment.

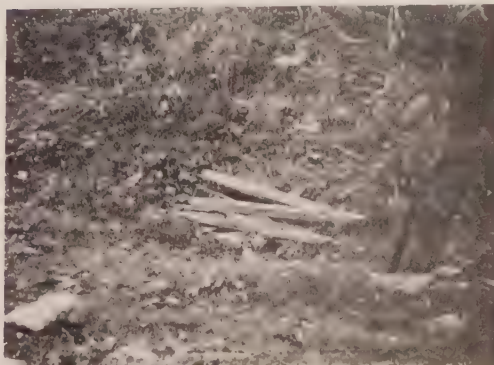
Top 4 feet of south abutment has been repaired.

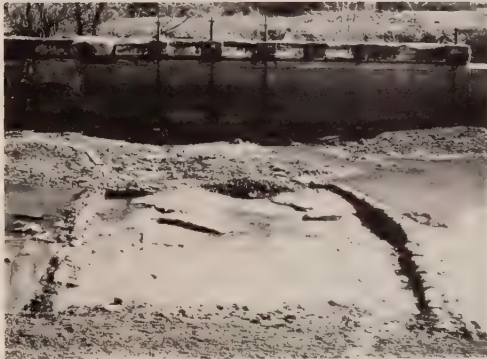
Looking South-Exposed Top of Culvert, Apr. 1976
Albion Waste Gate and Weir in background. Area
sandbagged off for repairs. Concrete lining over
top of culvert has mostly disappeared.

In the Spring of 1976, water was seen spouting up into the nearly drained canal when the culvert was flowing full. Later, the area above the culvert was sandbagged off and a hole down between stone blocks was found. The downstream channel was then cleaned out so the culvert could be entered and the entrance area was also cleaned of debris. The hole was patched with concrete and the canal filled. In late August, a large quantity of water was seen spouting out a 30-40' long section of the east barrel west wall near the south end. The west barrel could only be entered a short distance from the exit end. It was plugged by a 5-6' diameter tree trunk wedged between the floor and ceiling. On Sept. 15 the waste gates were closed and our first thorough inspection was made.

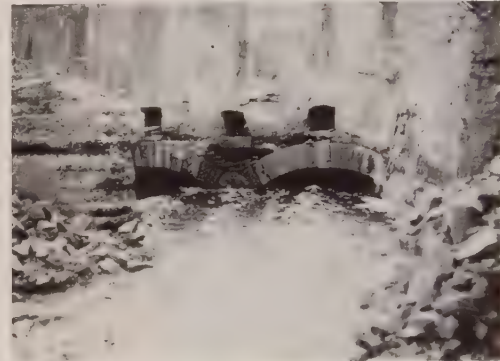
Entrance

Albion Waste Gate and Weir overhead. No airspace existed prior to cleaning of downstream channel. Note stones missing under middle gate in 1976. Compare with 1975 photo in Albion Waste Gate and Weir section.

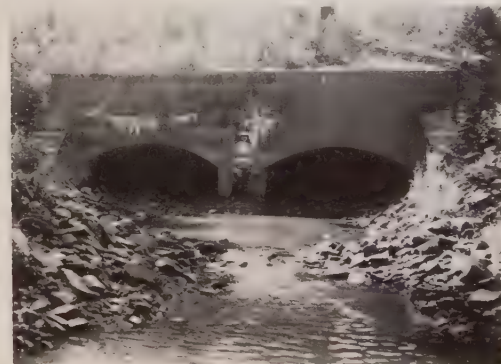
Exit

Headwall and wingwalls in good condition with a few cracks. Only 8" of airspace existed at exit prior to cleaning of downstream channel.

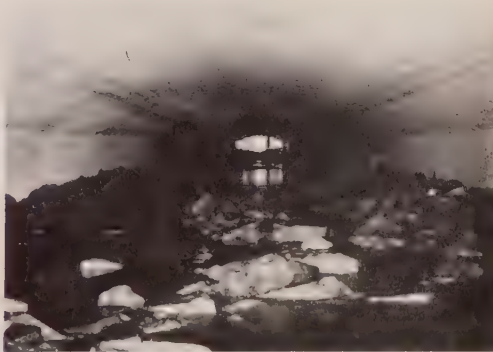
East Barrel-Looking South From Exit
Concrete arch had a few scattered efflorescent covered cracks. Stones in culvert and in exit channel appeared to be the remains of an old mill that existed at the culvert entrance.

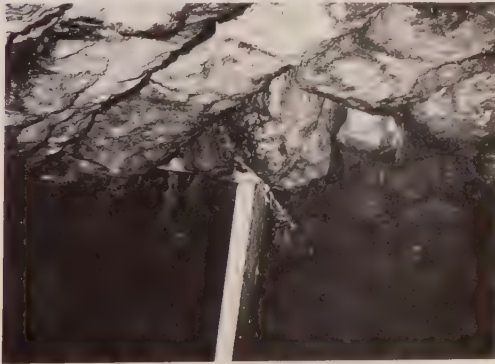
Ceiling of East Barrel
Large board used to prop up tilted and partially fallen stone block while overhead concrete repairs were made in the Spring of 1976. Two other adjacent stone blocks were partially missing. New concrete was seen high up in joints.

East Barrel - about 6 broken blocks within 10' of the entrance, but only 2 have partially fallen out. One block has slipped down 2". Numerous joints open between blocks. Many constantly dripping streams mainly in south half. Board used to prop up ceiling block while repairs were made. No leaks in area of repair. Heavy leak in west wall seen 2 weeks previous had stopped.

Sections of both barrels, mainly near the entrance, need repair. Work on unplugging the west barrel has been started. Both barrels need cleaning. Both north end concrete arches contained a few cracks, but were still in fair to good condition.

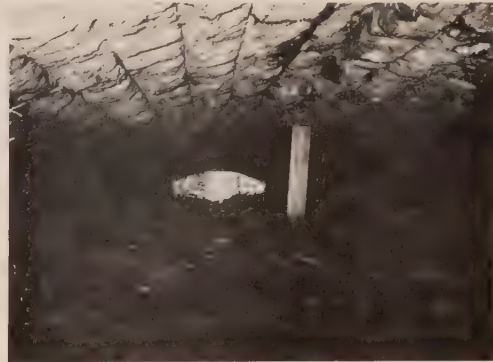
East Barrel-Looking South
Note row of ceiling blocks higher than others. Either the bottom sections of these blocks have fallen off or the blocks were never lowered to correct position.

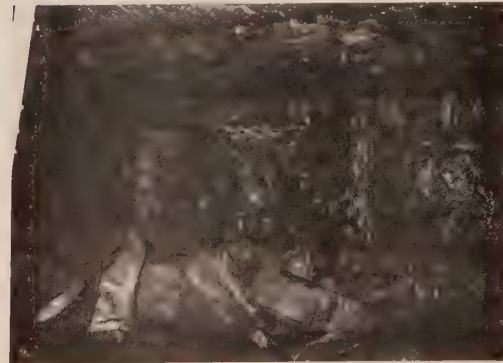
West Wall of East Barrel Near South End
Two weeks prior, a large quantity of water was seen coming through a 30-40' long section of the lower wall joint. All leaks had now stopped.

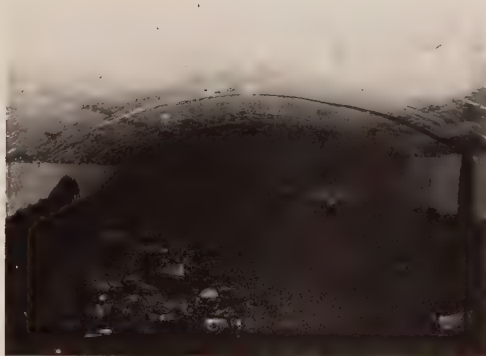
Plugged West Barrel - Looking South From Exit
Concrete arch had a few scattered
efflorescent covered cracks

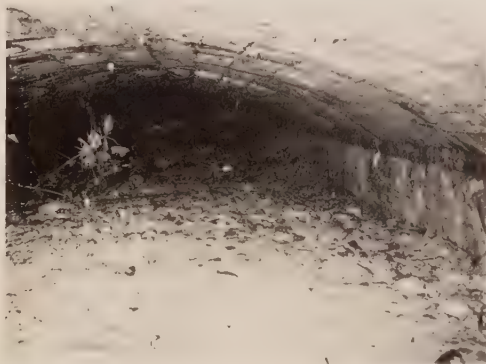
Plugged West Barrel - Looking North
Behind the plug, the culvert floor has filled up
with rocks and gravel. Another stone block exists
below wall at right. Compare with east barrel
wall photo.

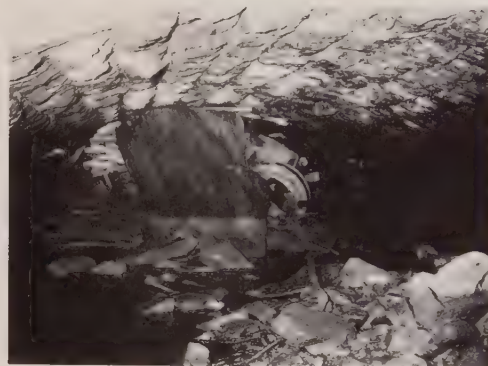
Plugged West Barrel
5-6' diameter tree trunk plugged culvert.
30' or more of debris was piled up behind trunk.

West Barrel - hole 1' square by 1' deep existed in a stone block 3' and 8' in from the entrance. Constant scattered dripping throughout. Drip size streams existed in 3 or 4 areas mainly in south half. Numerous joints open between stones. A few cracked blocks at entrance. Exit plugged.

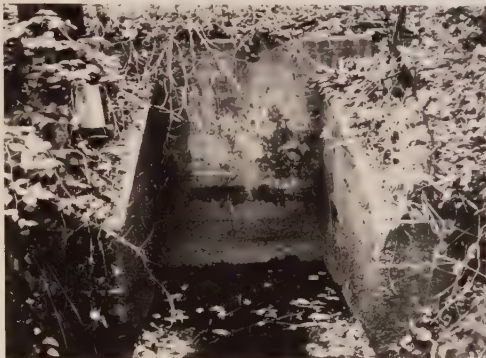
Exit

Headwall and wingwalls in good condition. Pipe half full of silt.

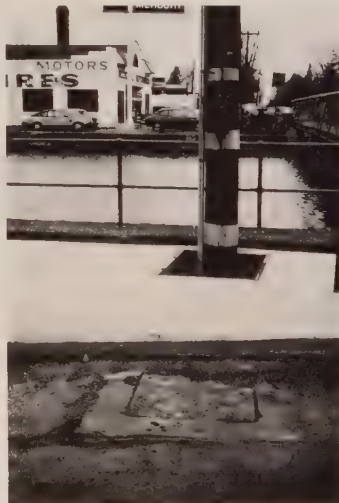
Entrance

Square manhole cover in foreground is entrance. Exit manhole is under car behind telephone pole on north side of canal. This Town of Albion storm sewer was allegedly cleaned out in 1974.

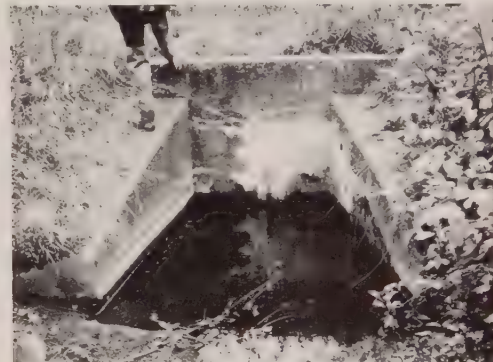
Exit

Headwall and wingwalls in fair condition due to many cracks. Culvert well filled with silt and drainage channel filled with vegetation.

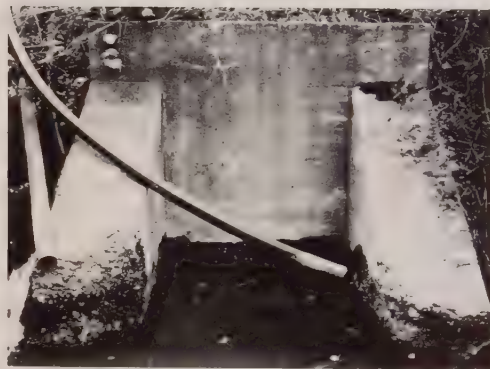
Since there are no other gates between this one and the Niagara River, the water level on the south side of the gate always remains at full depth. Due to periodic high water levels on the river, this guard gate is over 12 feet higher than the other guard gates. Whereas the other guard gates generally face east and west, this structure faces north and south.

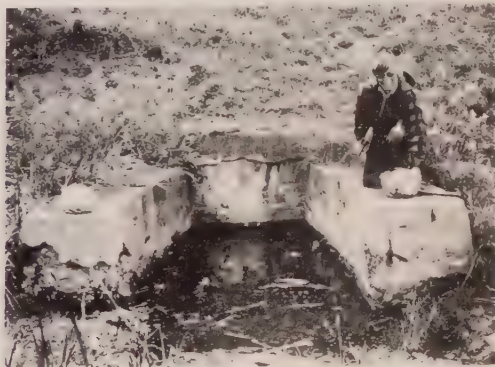
Erie Canal Section 10
Between Lockport and Sulphur Springs Guard Lock
LOCATION PLAN & SECTIONS OF
GUARD GATE STA. 6108+60 6107+80

Scales as indicated

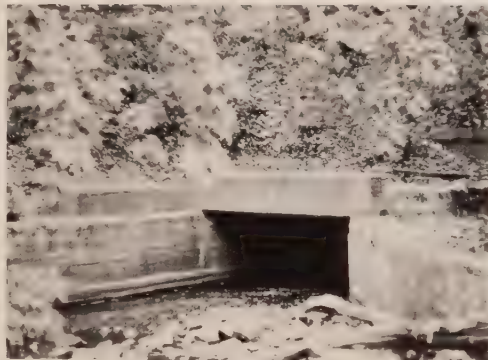
| Location | Length of Notch | Approximate Concrete |
|---|---|---|
| Adams Basin | 23.5' | 17 C.Y. |

| Location | Length of Notch | Approximate Concrete |
|---|---|---|
| Brookport | 10.0' | 6 C.Y. |

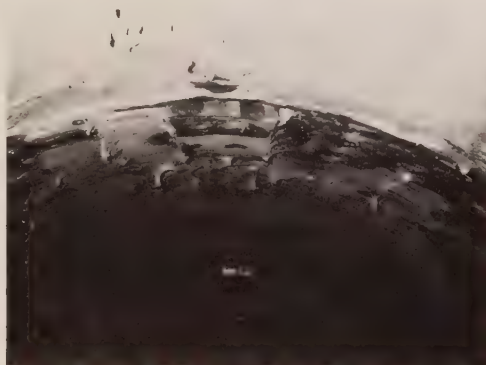
| Location | Length of Notch | Approximate Concrete |
|---|---|---|
| Brookville | 13.5' | 4 C.Y. |

| Location | Length of Notch | Approximate Concrete |
|---|---|---|
| Albion | 24.0' | 10 C.Y. |

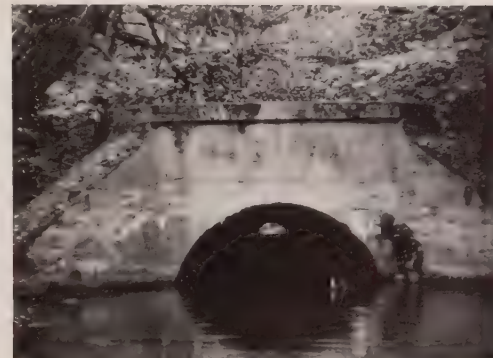
| Location | Length of Notch | Approximate Concrete |
|---|---|---|
| Medina | 60.0' | 36 C.Y. |

| Location | Length of Notch | Approximate Concrete |
|---|---|---|
| Mayhew | 14.0' | 4 C.Y. |

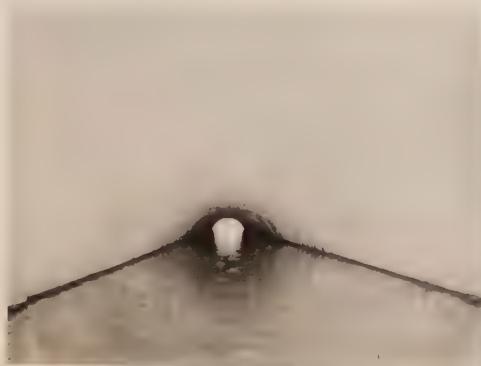
VIEW SHOWING TYPICAL CREST & NOTCH

FILL NOTCH IN WEIRS
Contract No. 163
 Erie Canal Sections 9 & 10
MAP SHOWING LOCATION OF WORK TO BE DONE
 Scale: 1 inch = 1 Mile

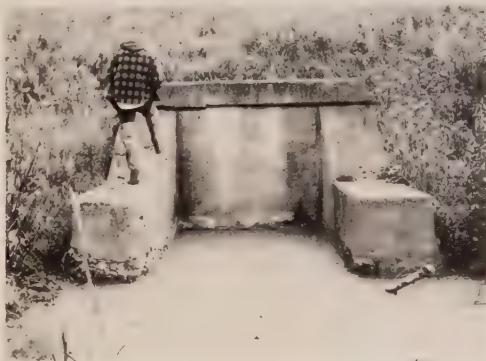
West Abutment
Fairport Weir

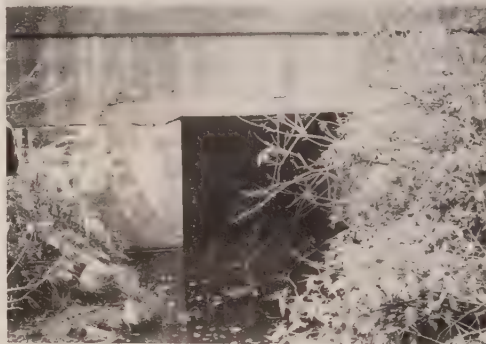
Due to the generally good condition of this waste gate and weir structure, and the deep water on both sides, no cores were taken and the concrete was not completely sounded for delaminations.

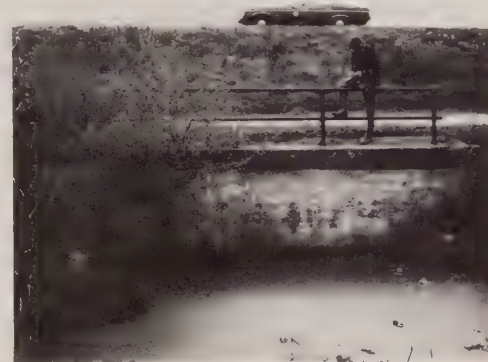
West Half, Note crack along crest
Fairport Weir

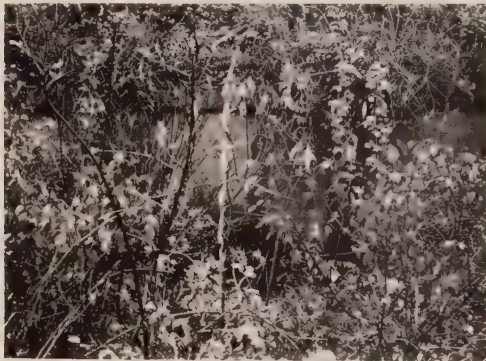
CONCLUSION

This new waste gate was in excellent condition and no work is recommended.

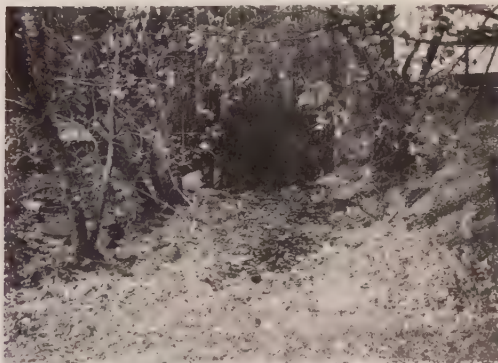
SPENCERPORT WEIR AND WASTE GATE

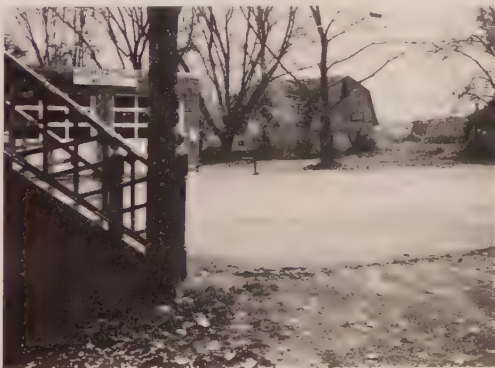
| <u>Core Number</u> | <u>Location</u> | <u>Scaled Depth</u> | <u>Deteriorated Depth</u> | <u>Intentional Breaks</u> | <u>Recovered Depth</u> | <u>Total Depth</u> | <u>Comments</u> |
|---|--|---|---|---|---|---|---|
| 1 | Waste Gate, North Side, 2' From West Abutment, 6' Above Floor | 0 | 12½" | 0 | 12½" | 12½" | Cored through cold joint. Deeper deterioration exists. |

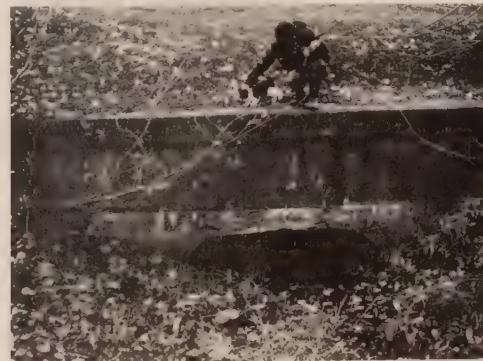
| <u>Core Number</u> | <u>Location</u> | <u>Scaled Depth</u> | <u>Deteriorated Depth</u> | <u>Intentional Breaks</u> | <u>Recovered Depth</u> | <u>Total Depth</u> | <u>Comments</u> |
|---|--|---|---|---|---|---|---|
| 4 | East Abutment, Canal Side, 5' From Weir, 4' From Bottom | 0 | 5" | At 9" | 21" | 21" | |

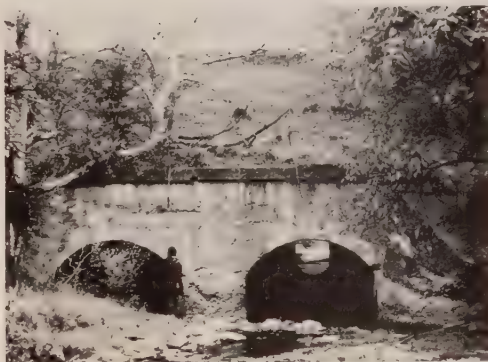
Entrance

Headwall and wingwalls were in fair to poor condition with numerous cracks, deep scaled and delaminated areas.

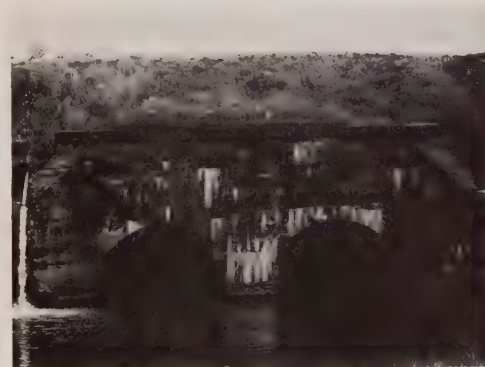
Exit

Headwall and wingwalls were in fair condition with many cracks, scaled and delaminated areas. Culvert floor is bedrock.

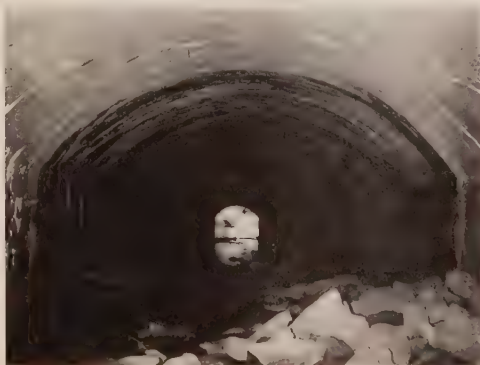
West Barrel - Looking North from Entrance

Both barrels contained similar deterioration - the concrete arches at the barrel ends had a number of efflorescent covered cracks. The concrete linings had many deep scale areas ranging in size up to 30 square feet. In 2 of these deep scale areas, the stone blocks behind the lining were exposed. Very little ceiling drainage, but one small stream was coming through the west side of the west barrel. Repairs are needed.

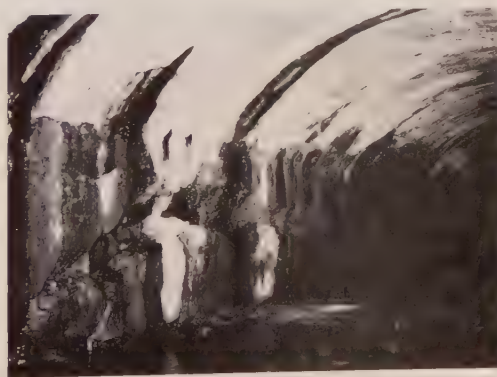
West Barrel - Deep Scaled Areas

Stone blocks can be seen behind the 8" thick concrete lining. Small stream coming through block wall in this area.

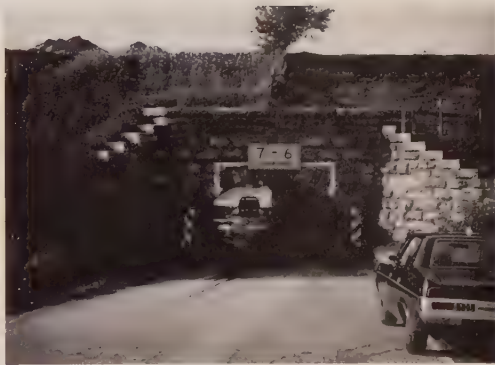
South End Headwall Aug. 1976
Dark area on lower left wingwall and west wall near south end began leaking seriously in Aug. 1976

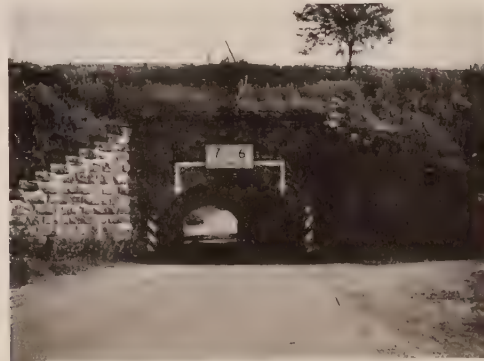
North End Headwall

This culvert was first inspected on Oct. 1, 1975. At that time, a number of areas mainly in the south half of the culvert were slowly dripping. The whole inside had been covered with shotcrete and about 25% of the shotcrete was now either missing, loose or delaminated. Although the concrete roadway was cracked, uneven in places and covered by water in some areas, the culvert looked in good condition.

On Nov. 20, 1975, while passing through the culvert, a heavy leak was seen coming through the west wall near the south end and the Region was notified.

This culvert has had a problem with leakage since it was built. In the 1918 Superintendent of Public Works Report, the following information was found: "Knowlesville road culvert has been leaking for some time. Leakage becomes serious during the month of October. Steel sheet piling driven in berme bank east of culvert and 2 boatloads of clay placed on south bank in prism. This cut off leak temporarily. I am informed by the division engineer that the canal prism is to be lined with concrete for a distance of 150', both east and west of culvert centerline."

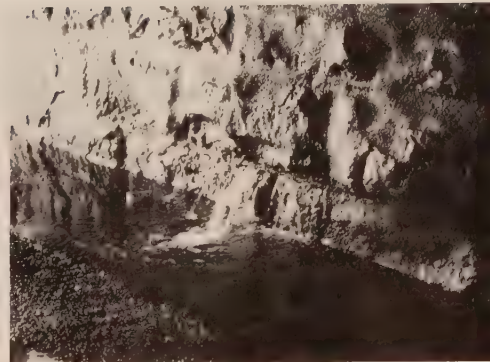
Leak Through West Wall 30' from South End, Nov. 1975

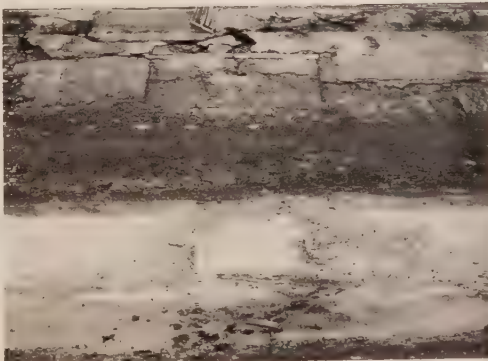
Looking South Directly Over Culvert
3-4" of concrete missing over center
of Culvert.
Note holes at top of south embankment.

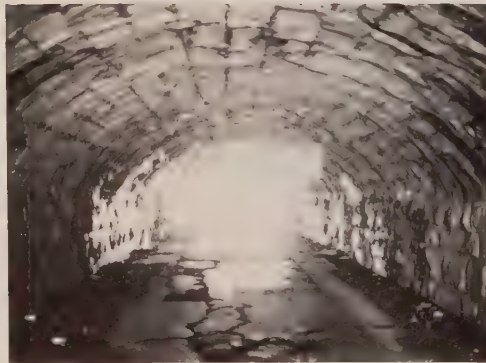
Looking North Near Center of Culvert
Leaks are from nearly dry canal.

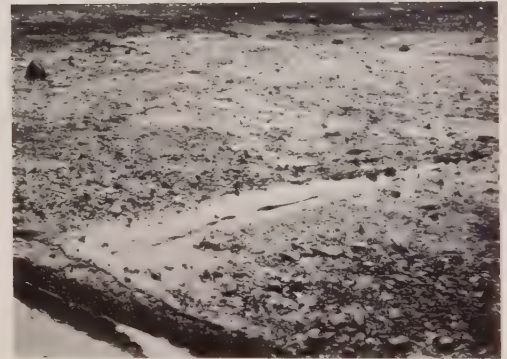
East Edge of Waterproofed Concrete Slab
Most of the 4" thick concrete top slab has dis-
appeared here.

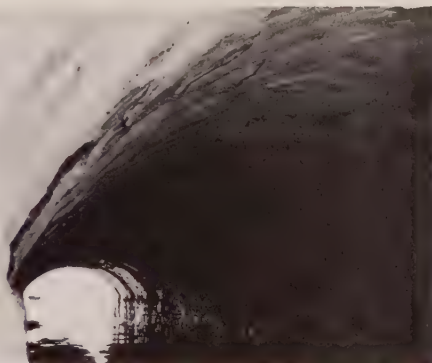
Looking South From North End
Heavy leaks developed along base of west wall about 50-100' in from entrance and at west wingwall.
Note loose shotcrete lining.

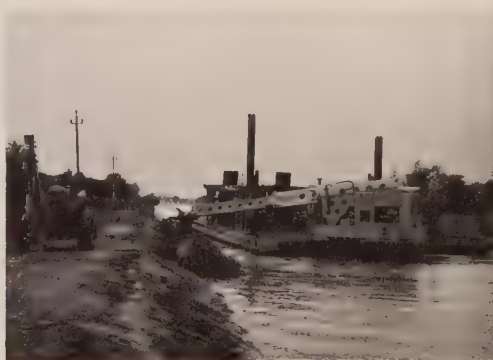
Looking West Along South Embankment From Culvert Centerline
In late Aug. 1976, the south embankment was lined with clay for approximately 75' on either side of the culvert in an attempt to stop leaks.

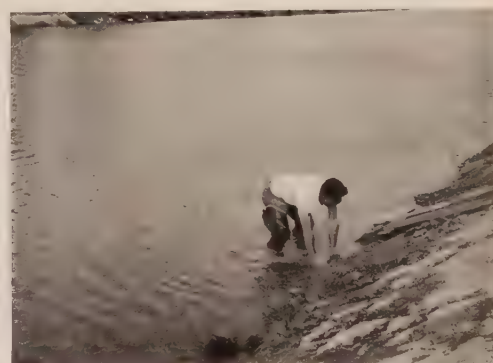
After the south embankment was lined with clay, 2 small whirlpools were seen near the water edge over the culvert. These were plugged by hand.

After the clay lining was placed, the rate of leakage had been cut by approximately 1/3. In the mean time, the decision was made to remove the old prism lining and replace it with a continuous waterproofing membrane. This work is to be done in the Spring of 1977 under Contract D95315.

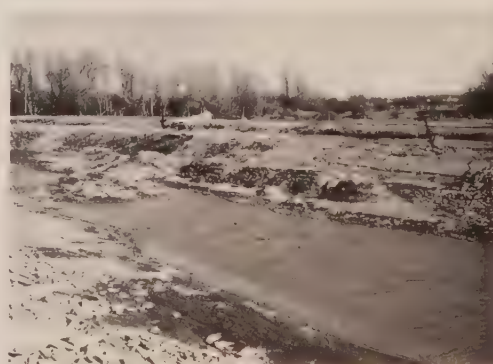
Looking East, March 1977 - Arrows Denote Holes
Most of the clay was on the canal bottom.

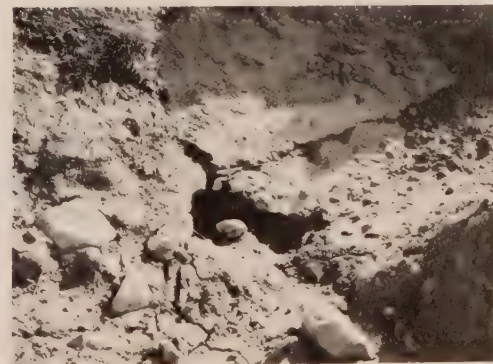
Leak Hole Found About 20' West of Fence
Clay only partially plugged hole.

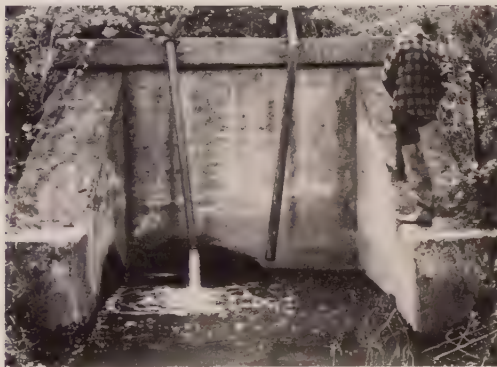
Exit

Headwall and most of wingwalls in good condition.
Low ends of both wingwalls were undermined and
appeared ready to fall off. 2-3" syphons, 1 active.

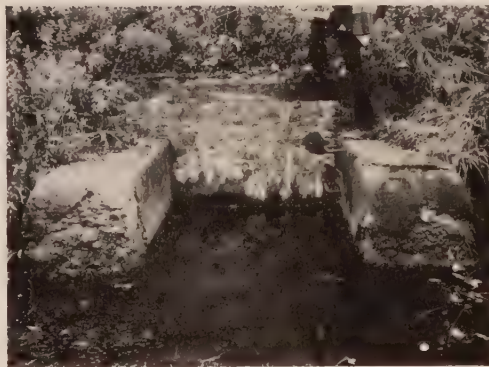
Exit

Headwall and wingwalls in fair to poor condition
with many cracks, scaled and delaminated areas. Very
deep culvert well.

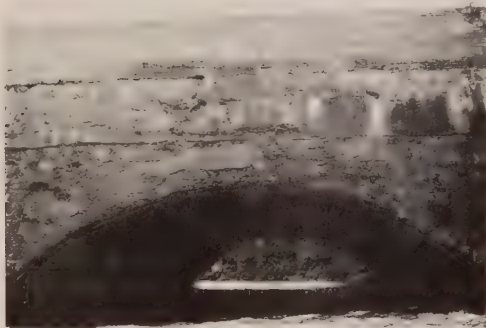
Entrance
Wall surface has partially scaled away

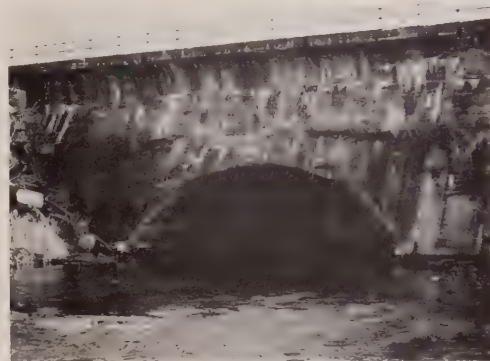
Exit
Canal towpath on top of wall. Note cracks and vegetation.

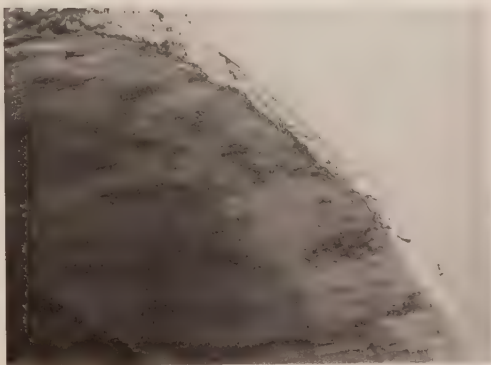
Edge of Arch Entrance
Note exposed steel bars and efflorescent covered cracks.

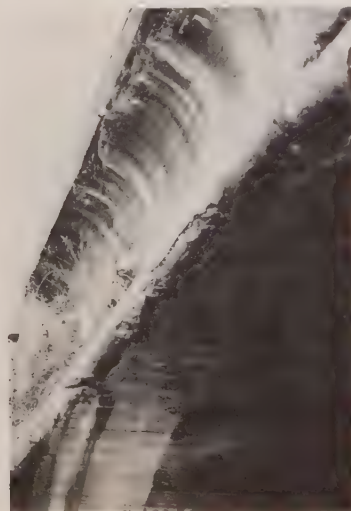
Edge of Arch Exit
Note scaling and efflorescent covered cracks.

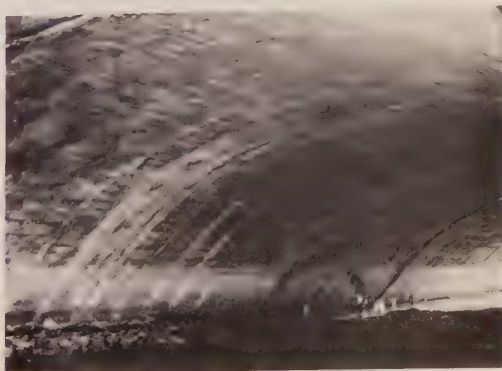
East Side of Arch
Note vertical efflorescent covered cracks at
3-4' spacing on lower section of arch wall.

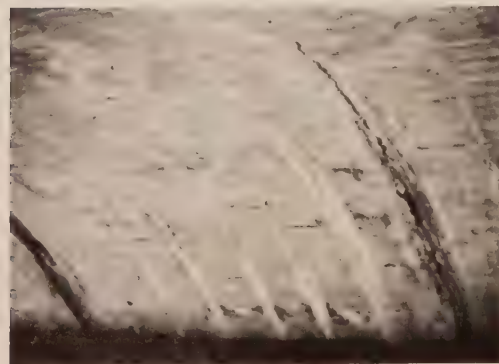
West Side of Arch
3-4' spacing of efflorescent covered cracks

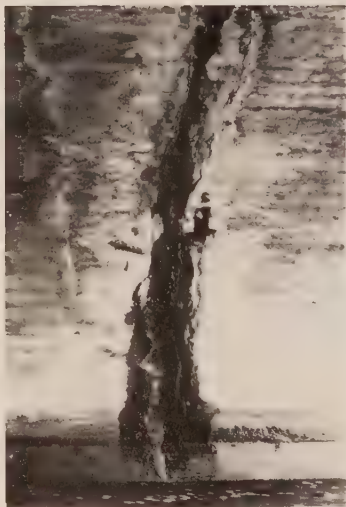
East Wall - 1st Joint from Entrance

From south to north (entrance to exit) - 6 construction joints exist in the arch barrel. The 1st joint was 50% scaled to a depth of 6" mainly on the south side of the joint. There was no leakage, but it was damp on both sides. The 2nd joint was 5% scaled and in good condition. There were no leaks, but it was coated with efflorescence. The 3rd joint was 20% scaled to a depth of 3". There was no leakage. The 4th joint had scaled 4" deep along 30% of the joint length. No obvious leaking. No scaling or leakage at joint 5. There was, however, some efflorescence and joint was damp on west half of barrel. Joint 6 was scaled approximately 8" deep along 50% of the joint. The east end of the joint has one scaled area 8" wide by 1' deep by 3' long. Dripping seen along entire length of joint. On both sides of the arch, there were efflorescent covered cracks spaced 3-4' apart only on the interior arch sections, not on the entrance and exit arch trough wall sections. These cracks line up with the steel arch ribs encased in concrete. Some repairs are needed on this large culvert.

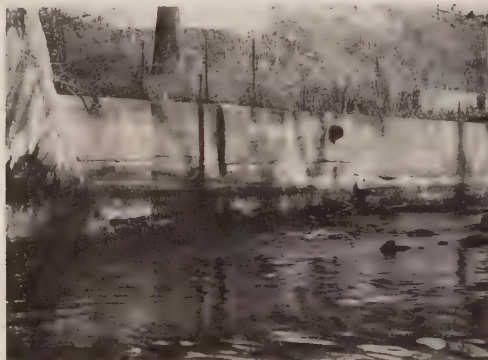
Retaining Wall on East Side Next to Entrance
Bottom of wall undermined. Large depression
behind left end of wall.

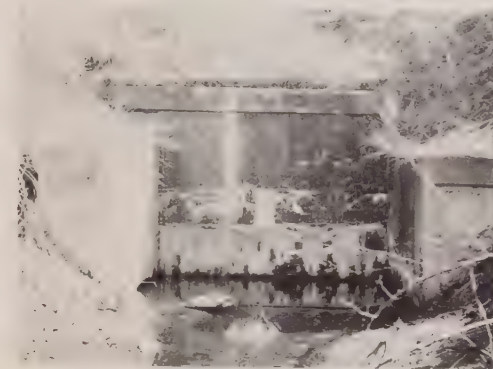
Exit

Headwall in fair condition with many efflorescent
covered cracks on bottom half. Left wingwall in
poor condition with many efflorescent covered
cracks and end scaled up to 6 inches deep. Right
wingwall in fair condition with many efflorescent
covered cracks on bottom half only and end scaled
up to 4 inches deep.

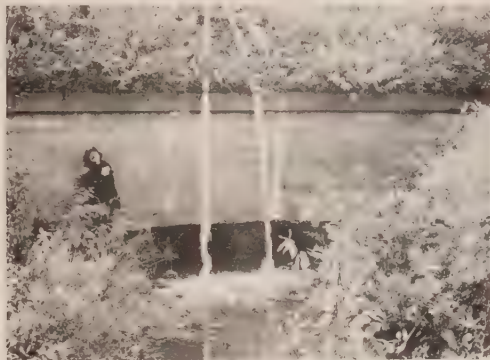
Exit

Concrete in headwall appeared to be in good condition, but the headwall was tilted. Half full of sewer water. Pipes appeared to be clean. 2-3" active syphons.

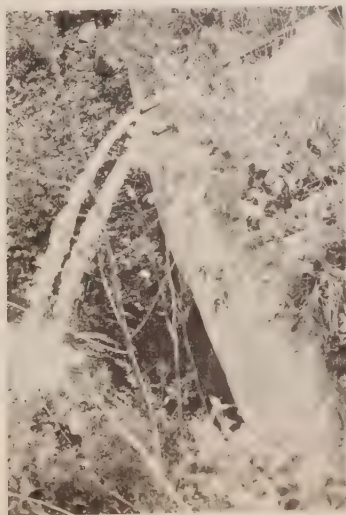
Headwall Tilted

A 2' diameter tree stump was seen at each end of the headwall. The trees apparently caused the headwall to tilt about 1' at the top.

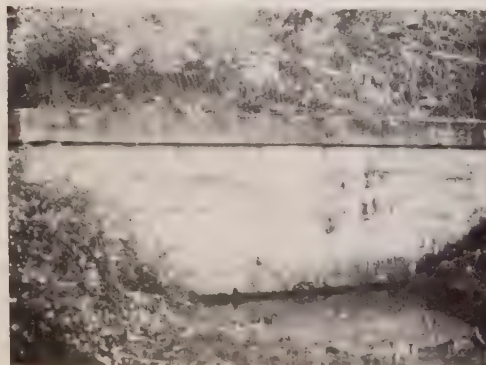
Exit

Headwall appeared to have been refaced with 1-3" of concrete. Facing was now delaminated and cracked. Top of pipe 6" under water. Drainage channel needs cleaning.
